# Inspection Report

St Charles Illinois 60174

Function and Safety Home Inspections

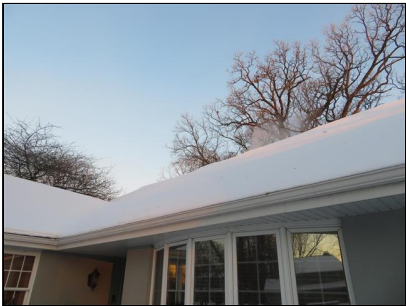
1.0 Item 1(Picture)

The roof was covered with snow at the time of the inspection

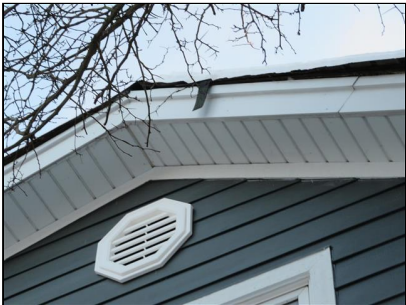
1.1 Item 1(Picture)

A piece of roofing material was hanging loose at the time of the inspection. Recommend repair as needed.

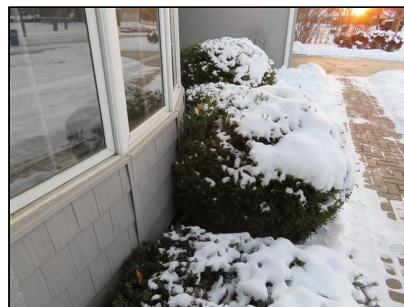
2.0 Item 1(Picture)

Vegetation was overgrown and needed to be cut back. All vegetation should be a minimum of 12 inches from the house.

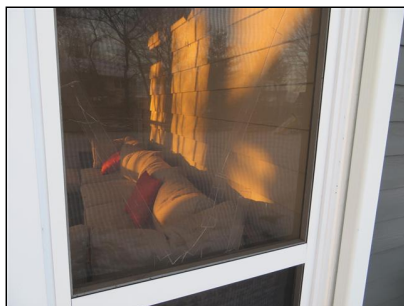
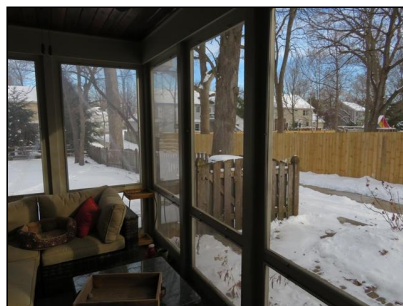
2.4 Item 1(Picture)

There were cracks in the plexiglass used in the screened in porch area. There were also missing plexiglass sections.

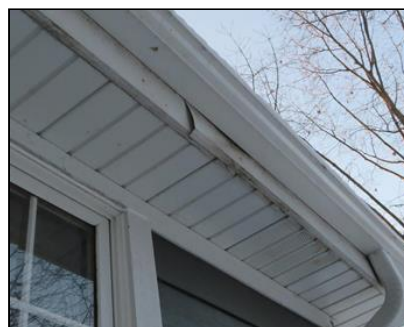
2.5 Item 1(Picture)

The fascia trim loose at the time of the inspection should be re-fastened by a qualified contractor.

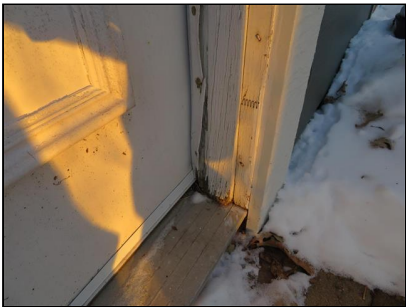
3.2 Item 1(Picture)

The exterior door trim shows signs of moisture damage. To prevent further wood rot I recommend sealing with paint

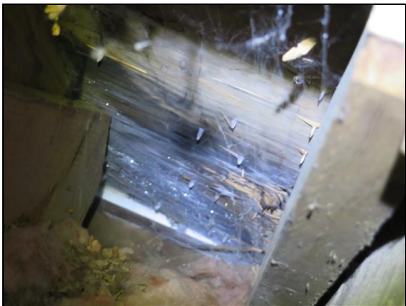
5.3 Item 1(Picture)

Roof sheathing had areas of discoloration that appeared to be the result of roof leakage. Behind the chimney roof intersection there was visible frost on the roof sheathing. The Inspector recommends that before the expiration of your Inspection Objection Deadline that this area be reviewed by a qualified roofing contractor to determine the chances for future leakage.

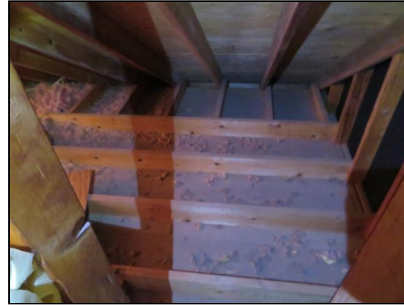
5.4 Item 1(Picture)

The attic floor insulation depth averaged approximately 6 to 8 inches. The Inspector recommends installing additional insulation to comply with local energy codes. Some areas were missing insulation which should be replaced.

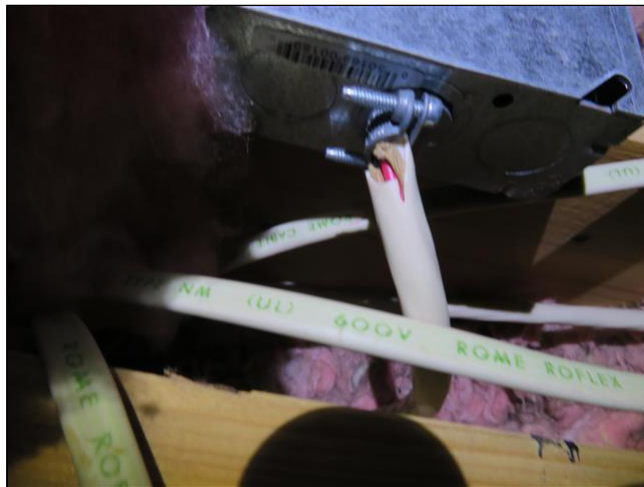
5.5 Item 1(Picture)

There was an improper wire attachment to a junction box. The spliced wire should only be visible in the junction box, not on the outside of it. This condition is a shock/ electrocution and potential fire hazard and should be corrected by a qualified electrical contractor.

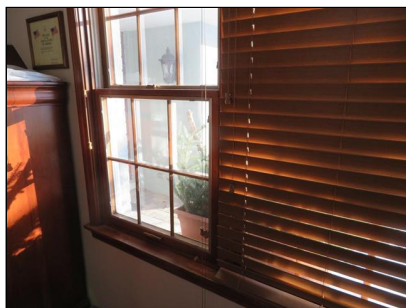
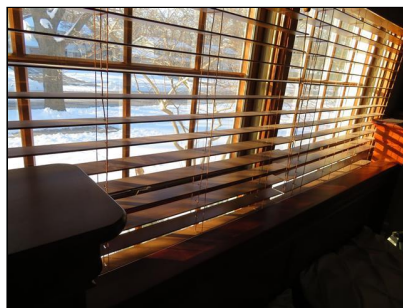
6.4.A Item 1(Picture)

Missing window screens

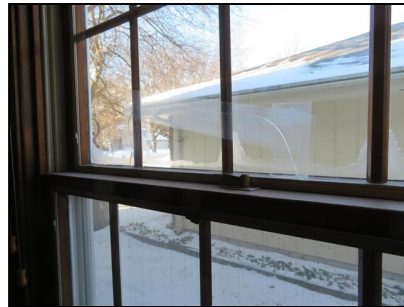
6.4.B Item 1(Picture)

The downstairs office had a window that was cracked. Recommend repair by a qualified contractor

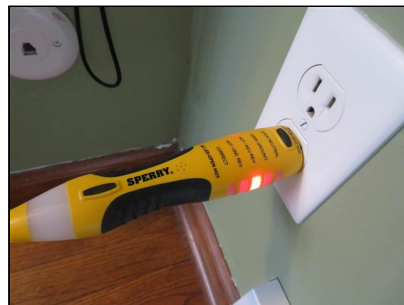
6.7.B Item 1(Picture)

An electrical outlet in the office had hot and neutral wires reversed. This condition should be corrected by a qualified electrical contractor.

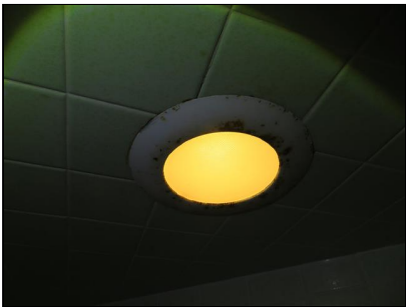
7.0.A Item 1(Picture)

The trim piece on the light above the shower has rusted. Recommend replacing.

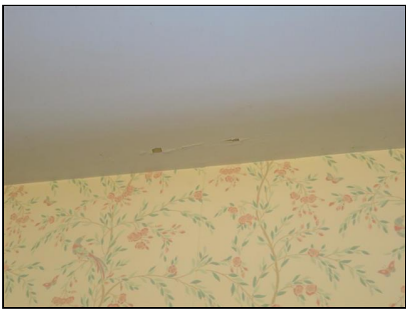
7.1.A Item 1(Picture)

Peeling Paint

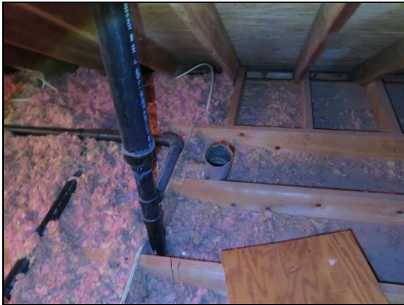
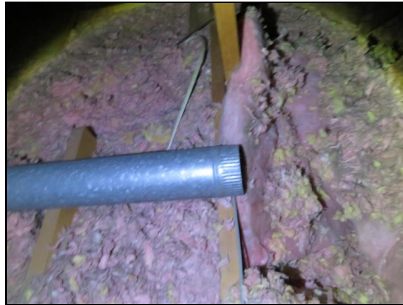
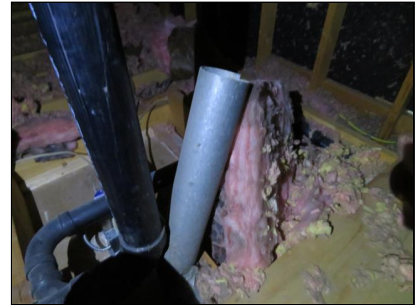
7.2.A Item 1(Picture)

The exhaust vents for the all the bathrooms terminated in the attic. This condition is improper and may result in mold growth or damage to home materials. The exhaust vent should terminate at the home exterior. The Inspector recommends correction by a qualified contractor.

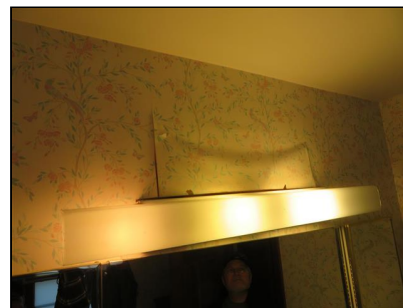
7.3.A Item 1(Picture)

Wall paper has come loose

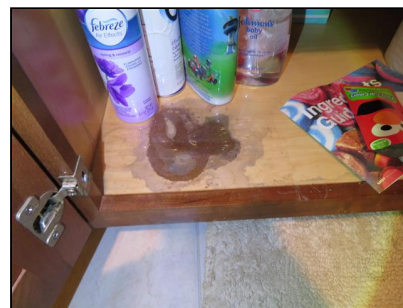
7.5.B Item 1(Picture)

In the upstairs hallway bathroom, the undersink cabinet floor had moderate damage which appeared to be the result of past leakage. The moisture meter showed no elevated levels of moisture present in the cabinet floor at the time of the inspection indicating that the source of leakage may have been corrected.

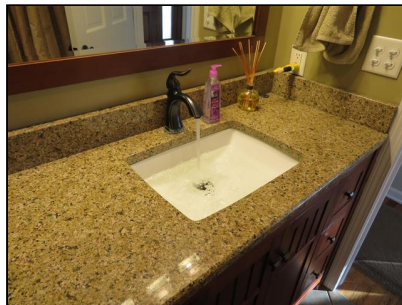
7.7.B Item 1(Picture)

The outlet in the downstairs bathroom was loose and should be reattached by a qualified electrician.

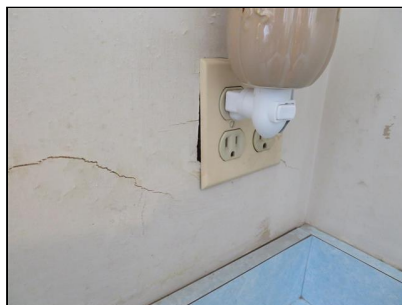
7.7.B Item 2(Picture)

The cover plate is installed incorrectly. Recommend repair by a qualified contractor.

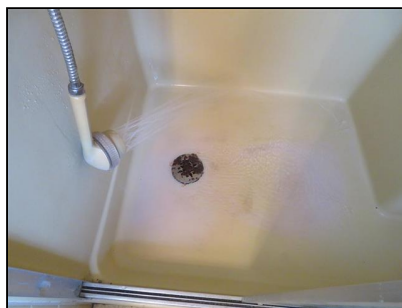
7.10.B Item 1(Picture)

One bathroom drain tile was rusted

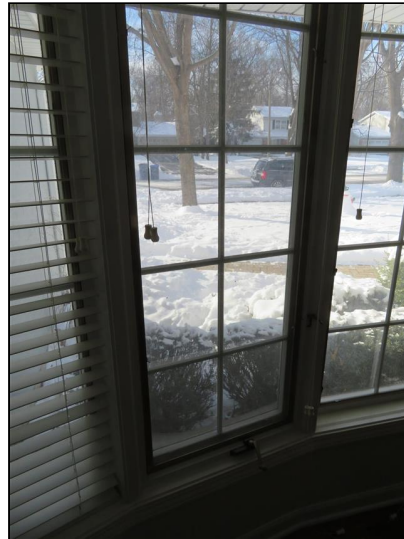
8.4 Item 1(Picture)

A window in the dining room was inoperable at the time of the inspection. The Inspector recommends service by a qualified contractor.

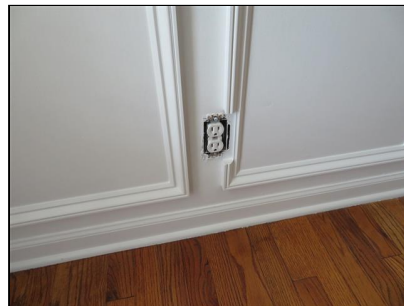
8.7 Item 1(Picture)

An electrical receptacle cover plate was missing in the dining room. This condition left energized electrical components exposed to touch, a shock/electrocution hazard. The Inspector recommends a cover plate be installed by a qualified electrical contractor.

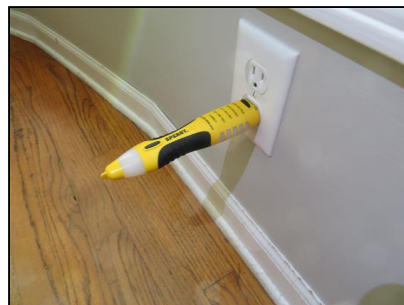
8.7 Item 2(Picture)

An electrical receptacle in the main floor family room was inoperable at the time of the inspection. The Inspector recommends service by a qualified electrical contractor. Below window.

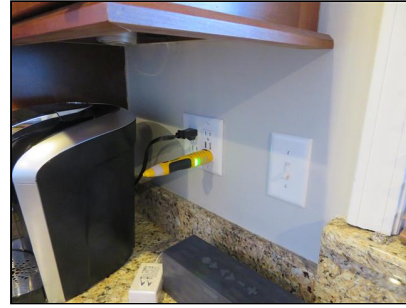
9.4 Item 1(Picture)

Electrical receptacles in the kitchen had no Ground Fault Circuit Interrupter (GFCI) protection. Although this condition may have been considered acceptable at the time the home was originally constructed, as knowledge of safe building practices has improved with the passage of time, building standards have changed to reflect current understanding. Consider having GFCI protection installed as a safety precaution for receptacles within 6 feet of a plumbing fixture.

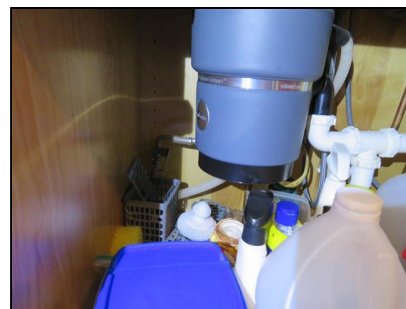
9.9 Item 1(Picture)

The dishwasher did not appear to have an anti-siphon device installed in the drain line. Anti-siphon devices are installed to prevent wastewater from the dishwasher from being siphoned back into the dishwasher and contaminating its contents. The Inspector recommends an anti-siphon device be installed by a qualified technician.

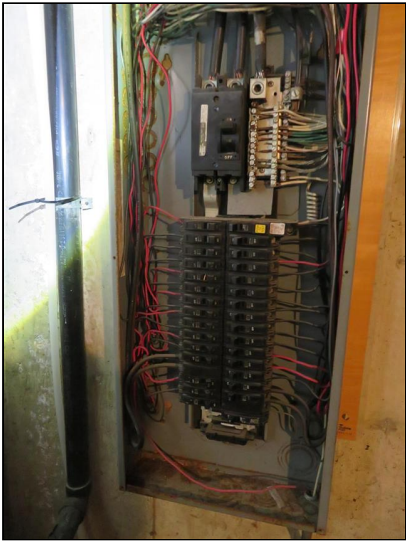
11.10 Item 1(Picture)

At the time of the inspection, the Inspector observed no deficiencies in the condition of circuit breakers in the electrical service panel.

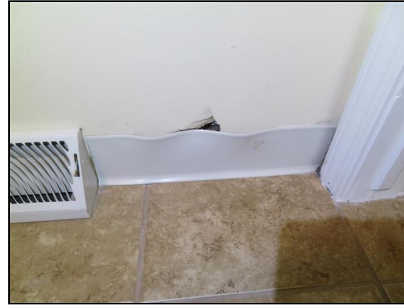
14.2 Item 1(Picture)

There is a hole in the laundry room wall by the floor.

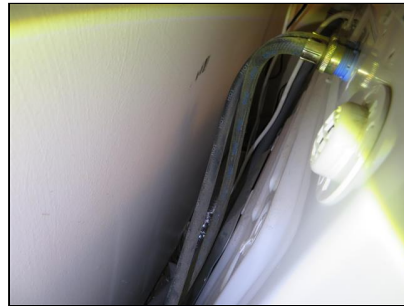
14.5 Item 1(Picture)

Rubber hoses should be replaced with more reliable ones - pressure-tested hoses. Such as stainless-steel, braided mesh hoses.

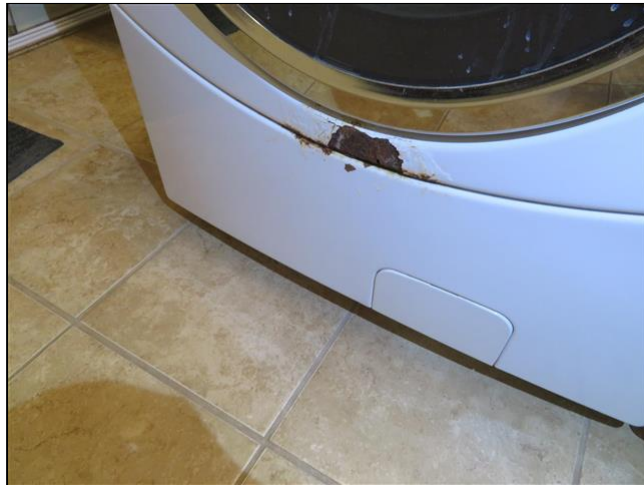
14.5 Item 2(Picture)

### **(2) Rust on the washer**

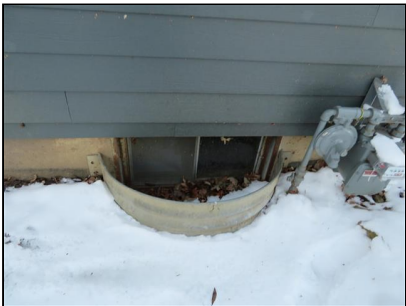
15.4 Item 1(Picture)

Some basement windows were missing the outside cover. Recommend adding them.

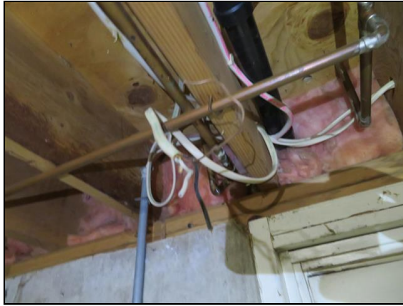
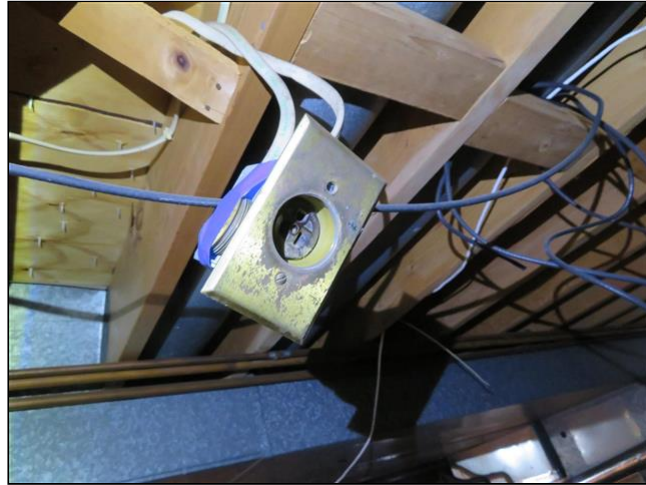
15.7 Item 1(Picture)

Energized electrical splices not contained within a junction box and exposed to touch were visible at the time of the inspection. Electrical splices should be contained within an approved junction box with a cover plate

installed. This condition is a shock/electrocution and potential fire hazard and should be corrected by a qualified electrical contractor. Also, a hanging outlet should be attached.

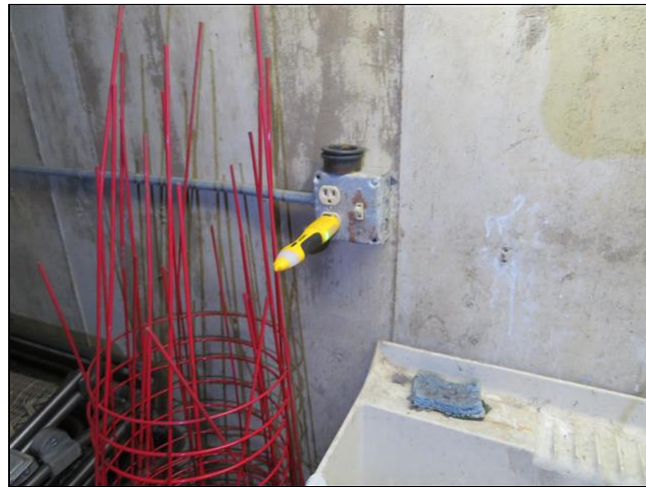
15.7 Item 3(Picture)

Electrical receptacles in the basement sink area had no Ground Fault Circuit Interrupter (GFCI) protection. Although this condition may have been considered acceptable at the time the home was originally constructed, as knowledge of safe building practices has improved with the passage of time, building standards have changed to reflect current understanding. Consider having GFCI protection installed as a safety precaution for receptacles within 6 feet of a plumbing fixture.
